## 1890 - Photograph

### *A photograph of the Colliery site in 1890 showing the completion of Shaft-D:*

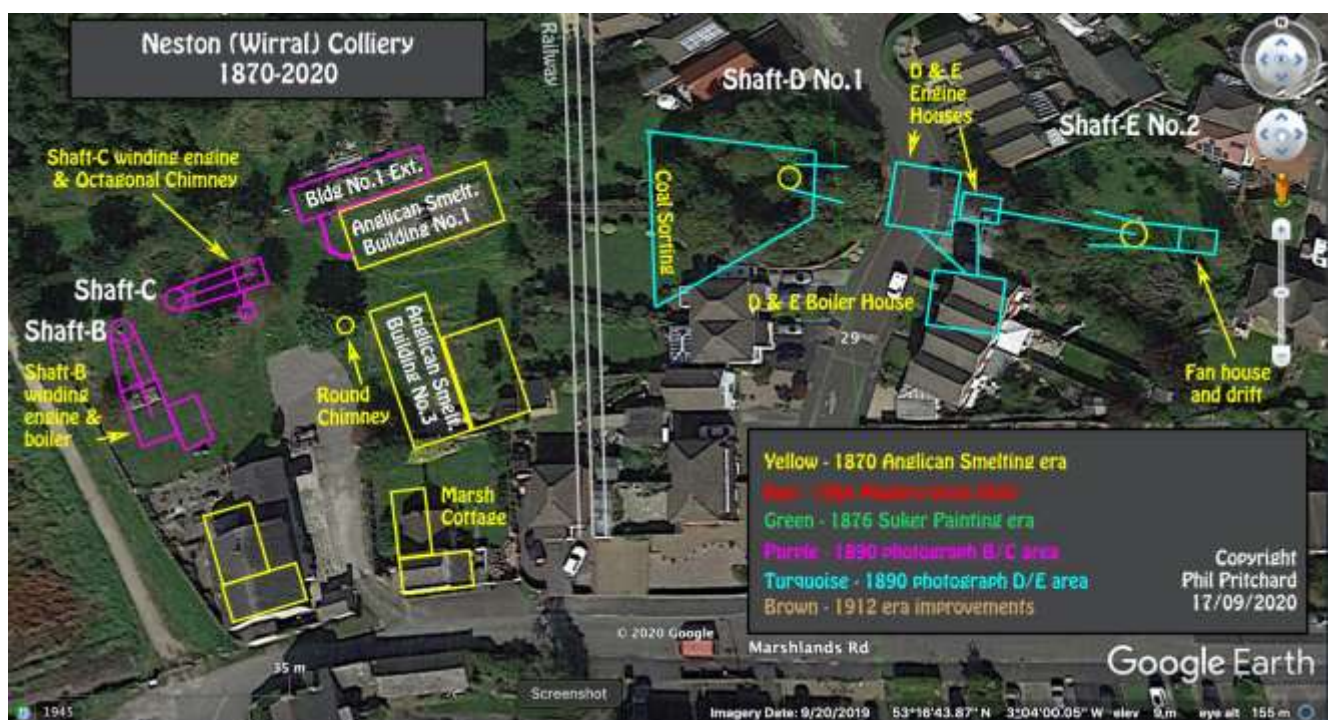
The picture below shows the layout at the date of the 1890 photograph, not all of the map is visible on the photograph. Note that the Building-2 (brickworks) chimney remains, despite the demolition of Building-2 – chimney demolition would be a specialised task and there were many other items of work to be carried out.

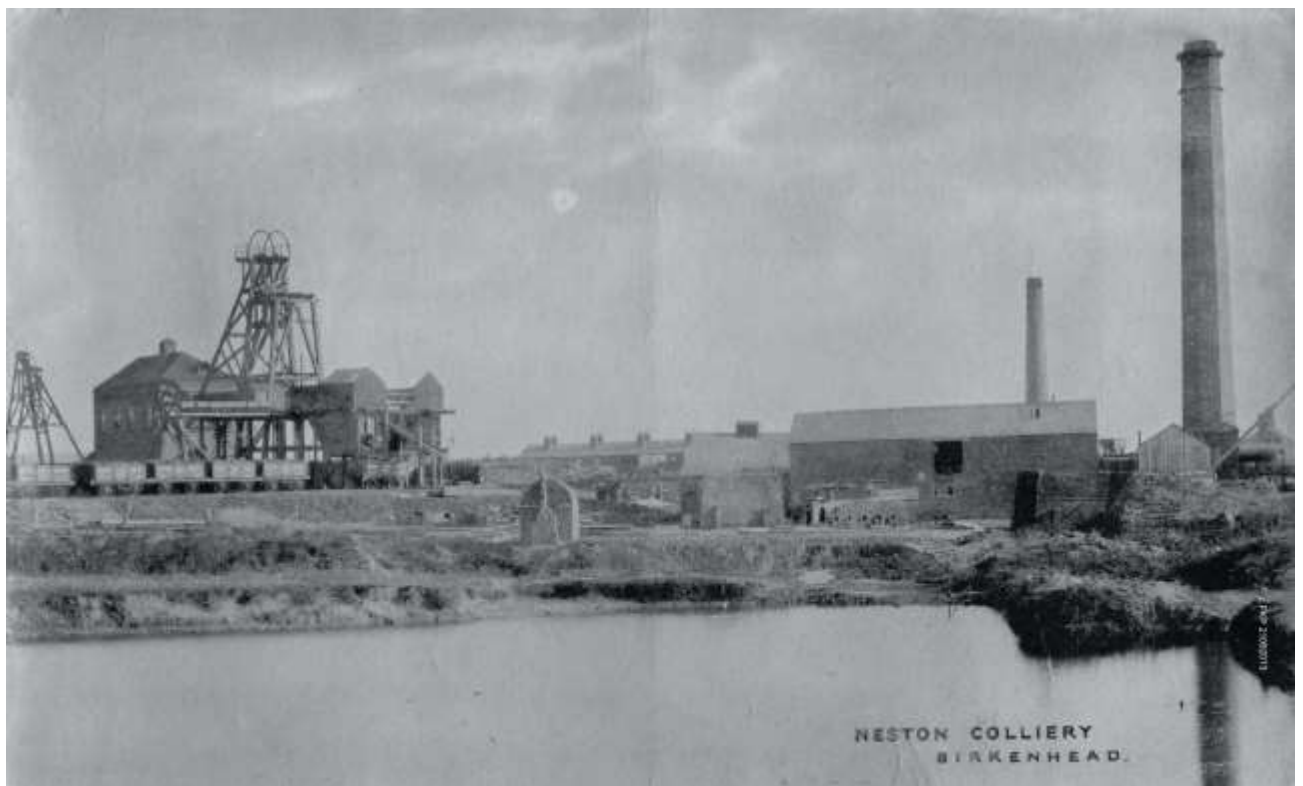
*Acknowledgements to Phil Pritchard (author)*

The original photograph is high quality, and was taken from a point looking south, between the two ponds (labelled 117 and 118)) in the bottom left quarter on the map

dated 1909. The two ponds were soon filled in and covered in pit waste as the colliery moved into full production. The amount of waste produced by the new colliery using modern mining methods was much greater than the previous era when the mining was more laborious.

1/. Headgear for Shaft (E) (**Wirral Colliery** shaft No.2). This shaft was required as a means of egress in an emergency to meet the new stringent underground access regulations, and also to act as a new ventilation shaft, after the disaster at Hartley Colliery. A later map has a building shown in line with the shaft, which would have been the fan house, connected to Shaft (E) via a fan drift to ventilate the whole mine operation underground. There was a fan included in the 1866 Anglican Smelting auction particulars, but it is doubtful if that was the one used here, mining ventilation fans were quite sizable and developed, even in 1890. In later years the shaft itself was modernised to carry compressed air pipes, and electricity for lighting cables.

2/. A new winding engine house for Shaft (D) is shown as being built, the structure itself appears complete, but notable is the absence of a boiler house chimney, the boiler house was on the other side of the boiler house and was a low structure, so may have simply have not been visible. When completed, the chimney was a square section. The right-hand side of the tiled roof shows an exit slot for the winding rope, leading up to the winding wheels on the headgear, but the rope had not been installed at the time of the photograph, neither had the cage guide wire hangers, these hung off the crosspieces at the top of the wooden headgear and are clearly visible on other contemporary photographs of the headgear.

3/. In front of the Shaft (D) headgear are some wooden building structures, which would have been used to unload coal hauled out of the colliery via Shaft (D) into lines of waiting 10-ton wooden wagons. The photograph shows some rail wagons, proudly bearing the lettering "Neston Colliery Company". The southernmost of the two structures was not complete in the photograph and had not been roofed. There is a gas light hanging from a beam out of each of the two transverse ridge roofed buildings.

4/. On the skyline in the middle of the picture is the roofline and chimneys of the early miner's cottages, known as "7-Row", they are still standing in 2021.

5/. In front of the “7-Row” in the foreground is a small round topped brick structure, this would be the magazine for storing mining explosives, it has a vent on the top. The round top style is seen in a few places around North Wales, such as this example here from Hanabys Level, nr Ffrith, Flintshire.

6/. The ponds only appear on the 1899 OS Map, they were soon covered up with pit waste to quite a depth – and still are to this day. It is understood that some of the buildings on Riverside are advised not to let any water drain into the soil, only into the piped drainage system to avoid any slippage.

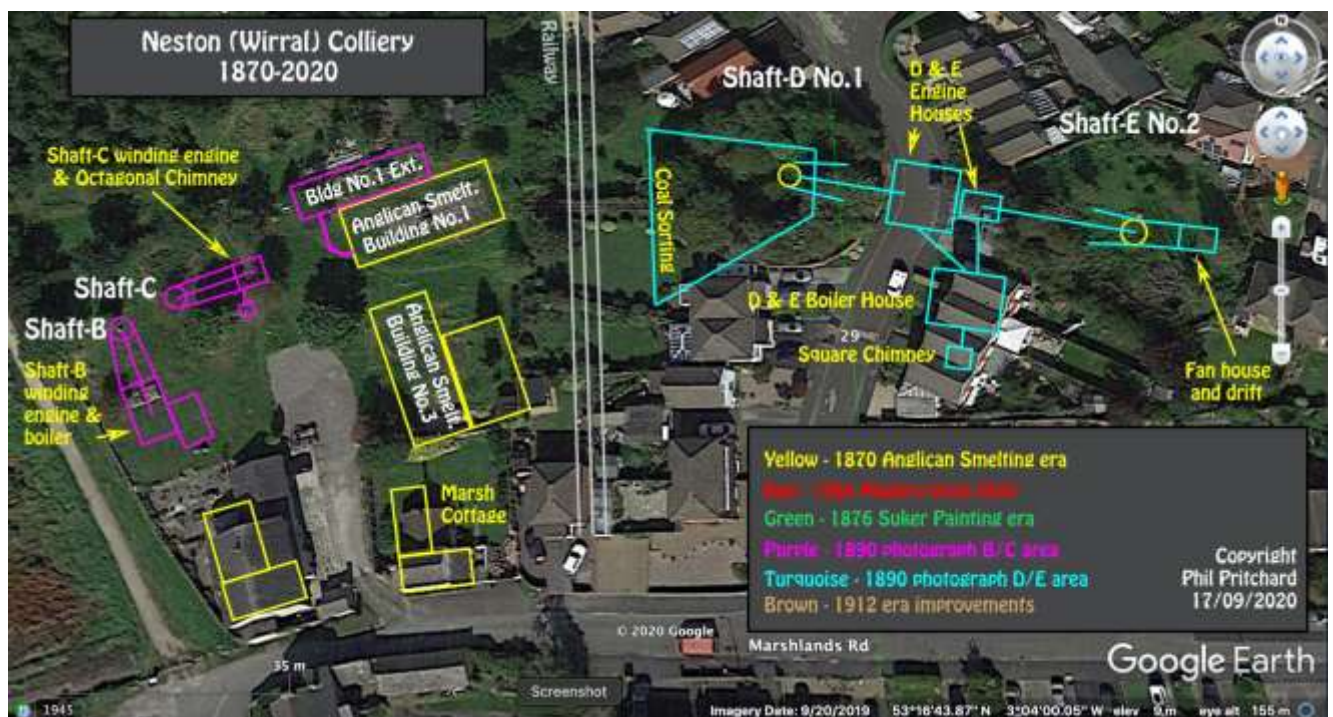
The picture below shows the colliery in its undeveloped operating layout. There is no evidence that Shafts (B&C) are actually used, except in emergencies. At some unknown date Shaft (C) was taken out of use and filled in, however, it must have had an operational life after 1890, because it had just had a new winding engine and headgear installed at the time of the 1890 photograph.

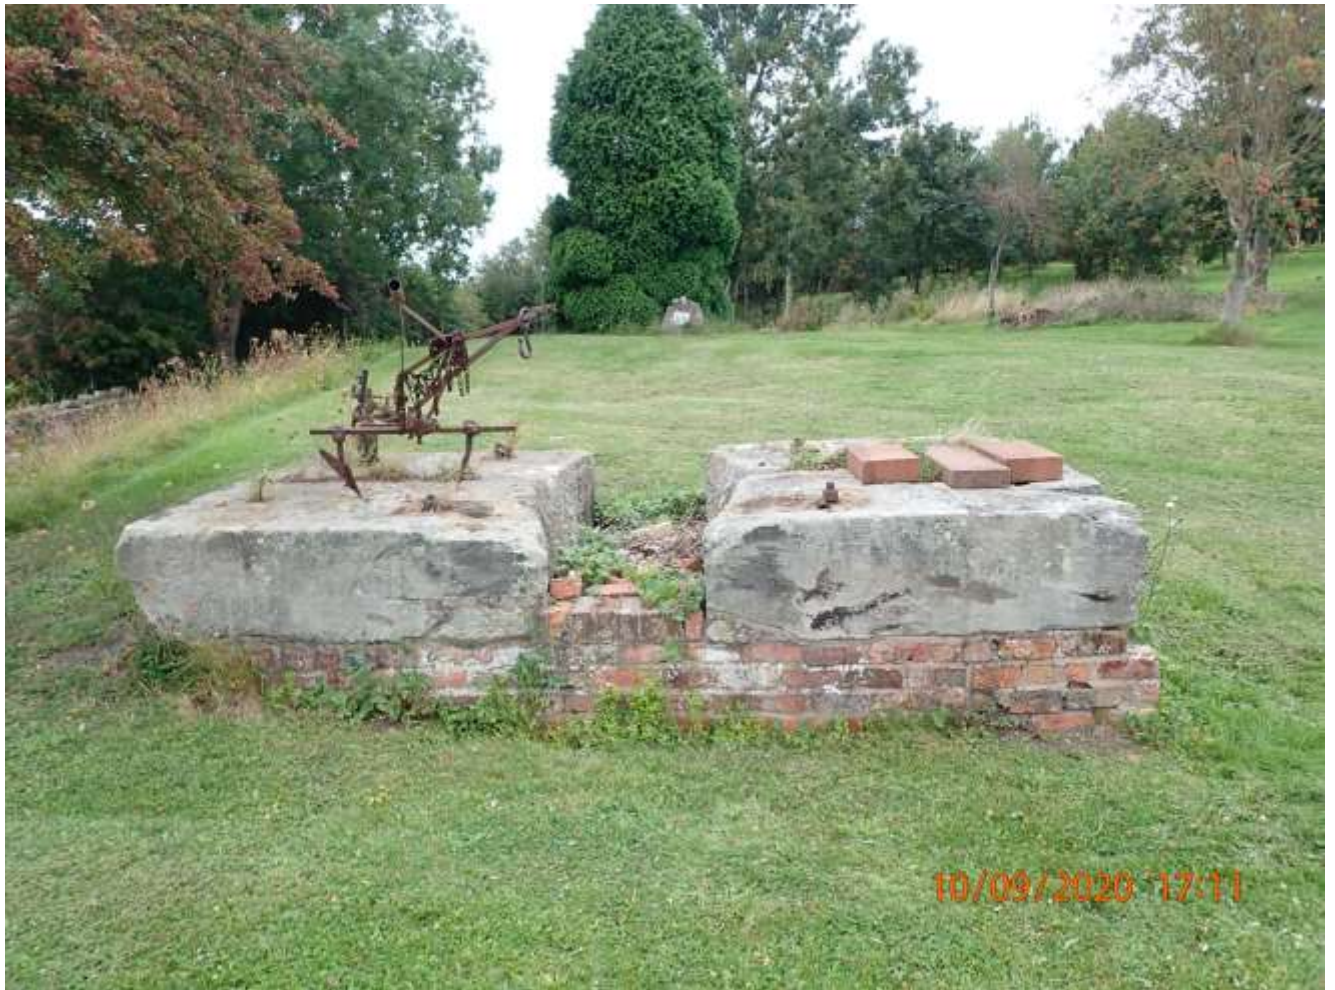
Shaft (B) engine bed looking north, the Shaft (B) NCB 'Monument' in the distance on the centre line. The NCB 'Monument' is used to denote the centreline of a coal mine shaft that has been filled in. The monuments often have a plate attached showing details, which usually quickly disappear. This is the monument that retained a Blue & Yellow NCB sign for many years.

Shaft (B) is also unique in that headgear has some remains still in existence, the winding engine bed is a large concrete structure in the current property owner's garden, as is a NCB concrete Monument marker (used to denote the location of old shafts), the author recalls there being a blue & yellow NCB sign on the engine bed, back as recently as 1985.
